ELLIOTT BAY SEAWALL PROJECT

Shoreline and Coastal
Planners Group
Jessica Murphy
July 11, 2017

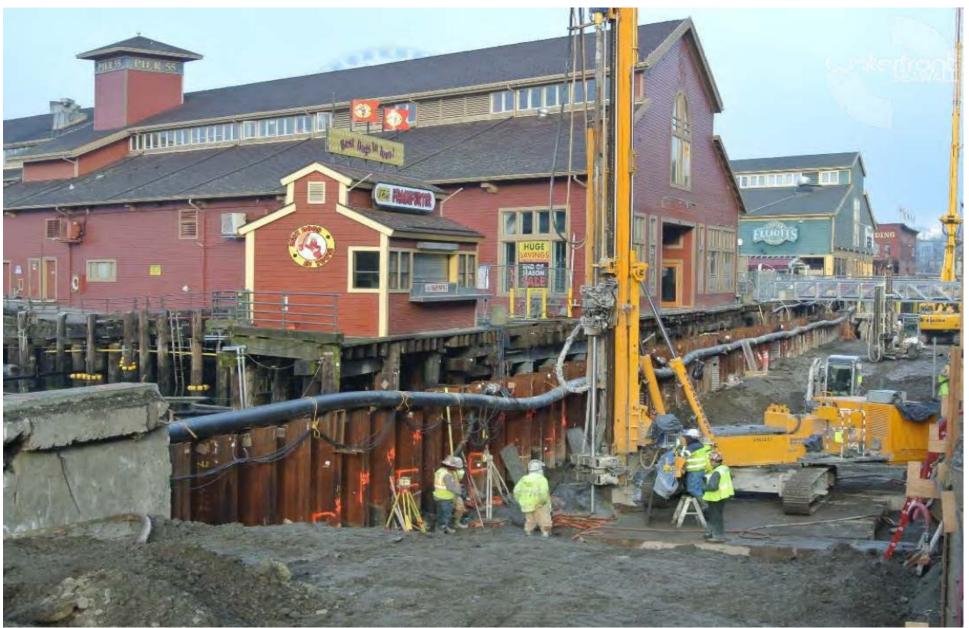
JET GROUT

Step 1 Step 2 Step 3 **Guide Hole** Grout Column Air Water Grout

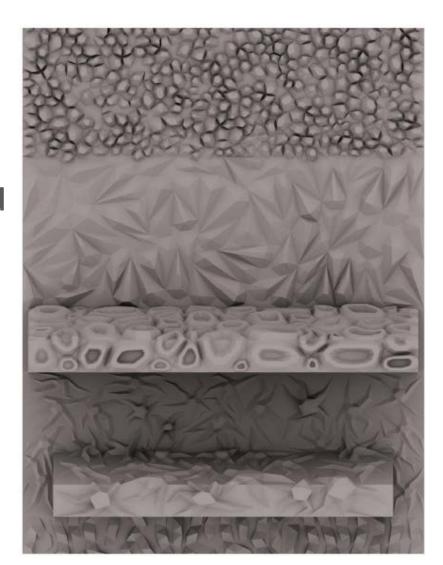
WALL FACE TEXTURE STUDY

- Four year study
- Test panels attached to existing seawall
- Several different panel textures and designs studied
- Textured wall surfaces promoted additional habitat growth

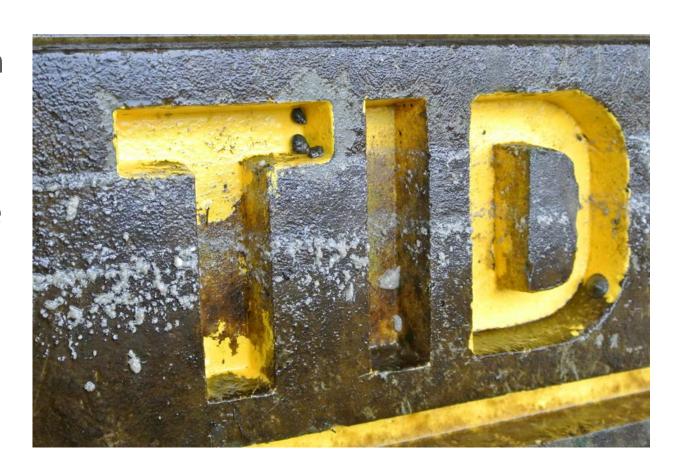
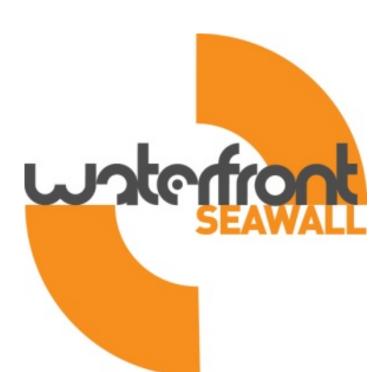
FUTURE MONITORING

- Light penetration
- Invertebrate colonization
- Salmon presence and behavior
- Adaptive design elements
- Seismic monitoring

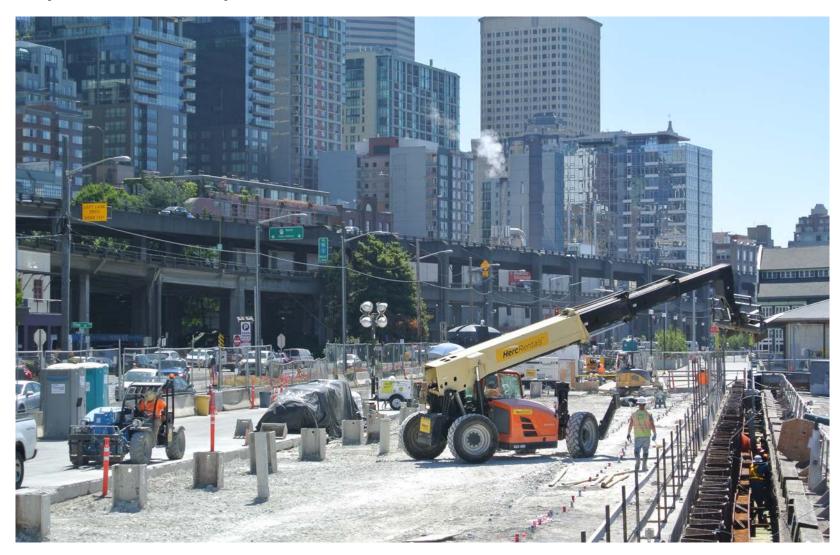
WORK IN BOX 1

Expected completion fall 2017
